POWER LINE ENTANGLEMENT HAZARD TO RAPTORS

Darrell I. Gretz

January 1981

Darrell Gretz, Wildlife Biologist
U.S. Fish and Wildlife Service, Denver, CO

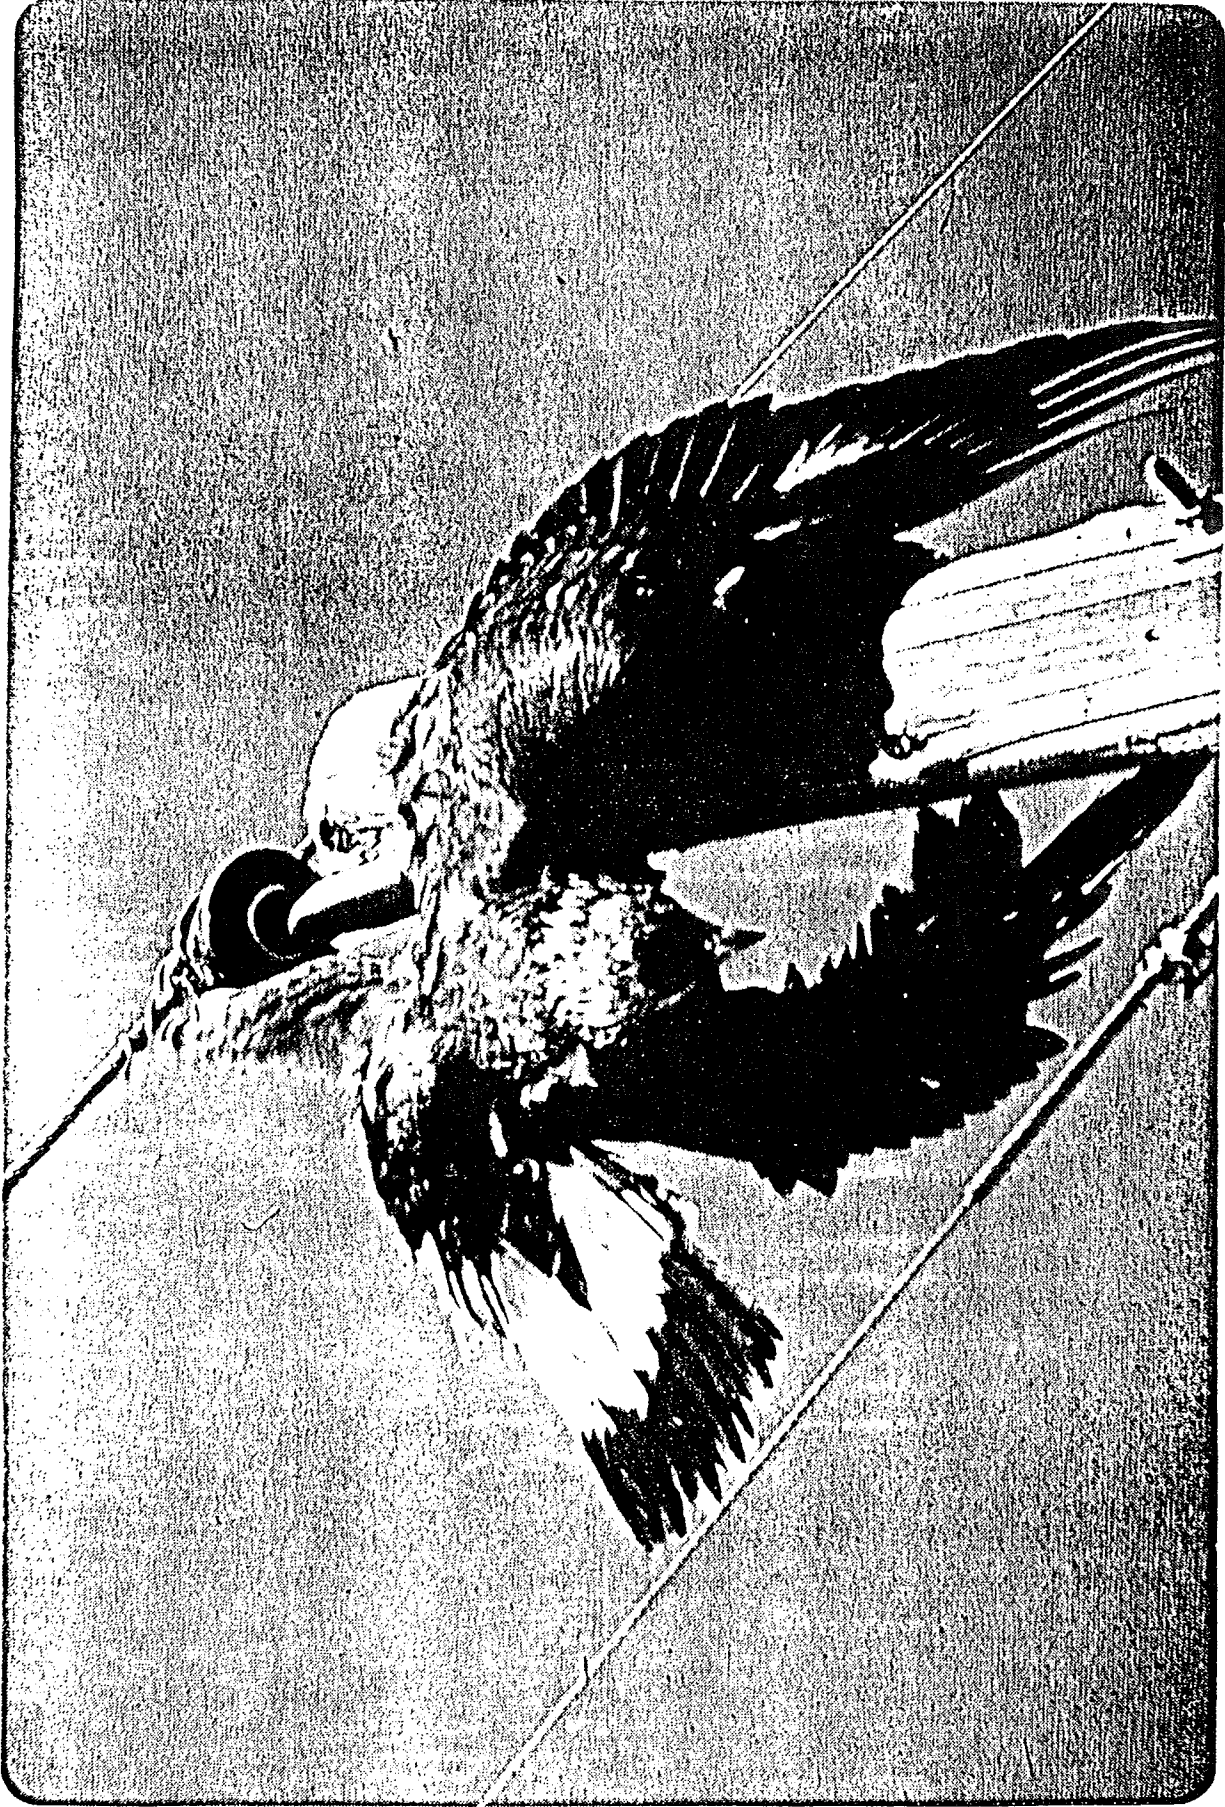
An article entitled "Raptor Mortalities Power Lines Studied" by Vi Solt appeared in the August-September 1980 issue of Fish and Wildlife News. The accompanying photograph of an "electrocuted Golden Eagle" by Peter Carboni, recalled a discovery that District Supervisor Vic Keenan (retired) and I made in 1974. While investigating a reported Golden Eagle electrocution in SE Colorado, we found another hazard to raptors from power lines--entanglement on the line. Under magnification it can be seen in Mr. Carboni's photo (color photocopy #1) that a talon is caught between the loosely wrapped wire that holds the power line to the insulator. It can also be noted that the other talons are open and that the only thing holding the eagle to the line is his entangled talon.

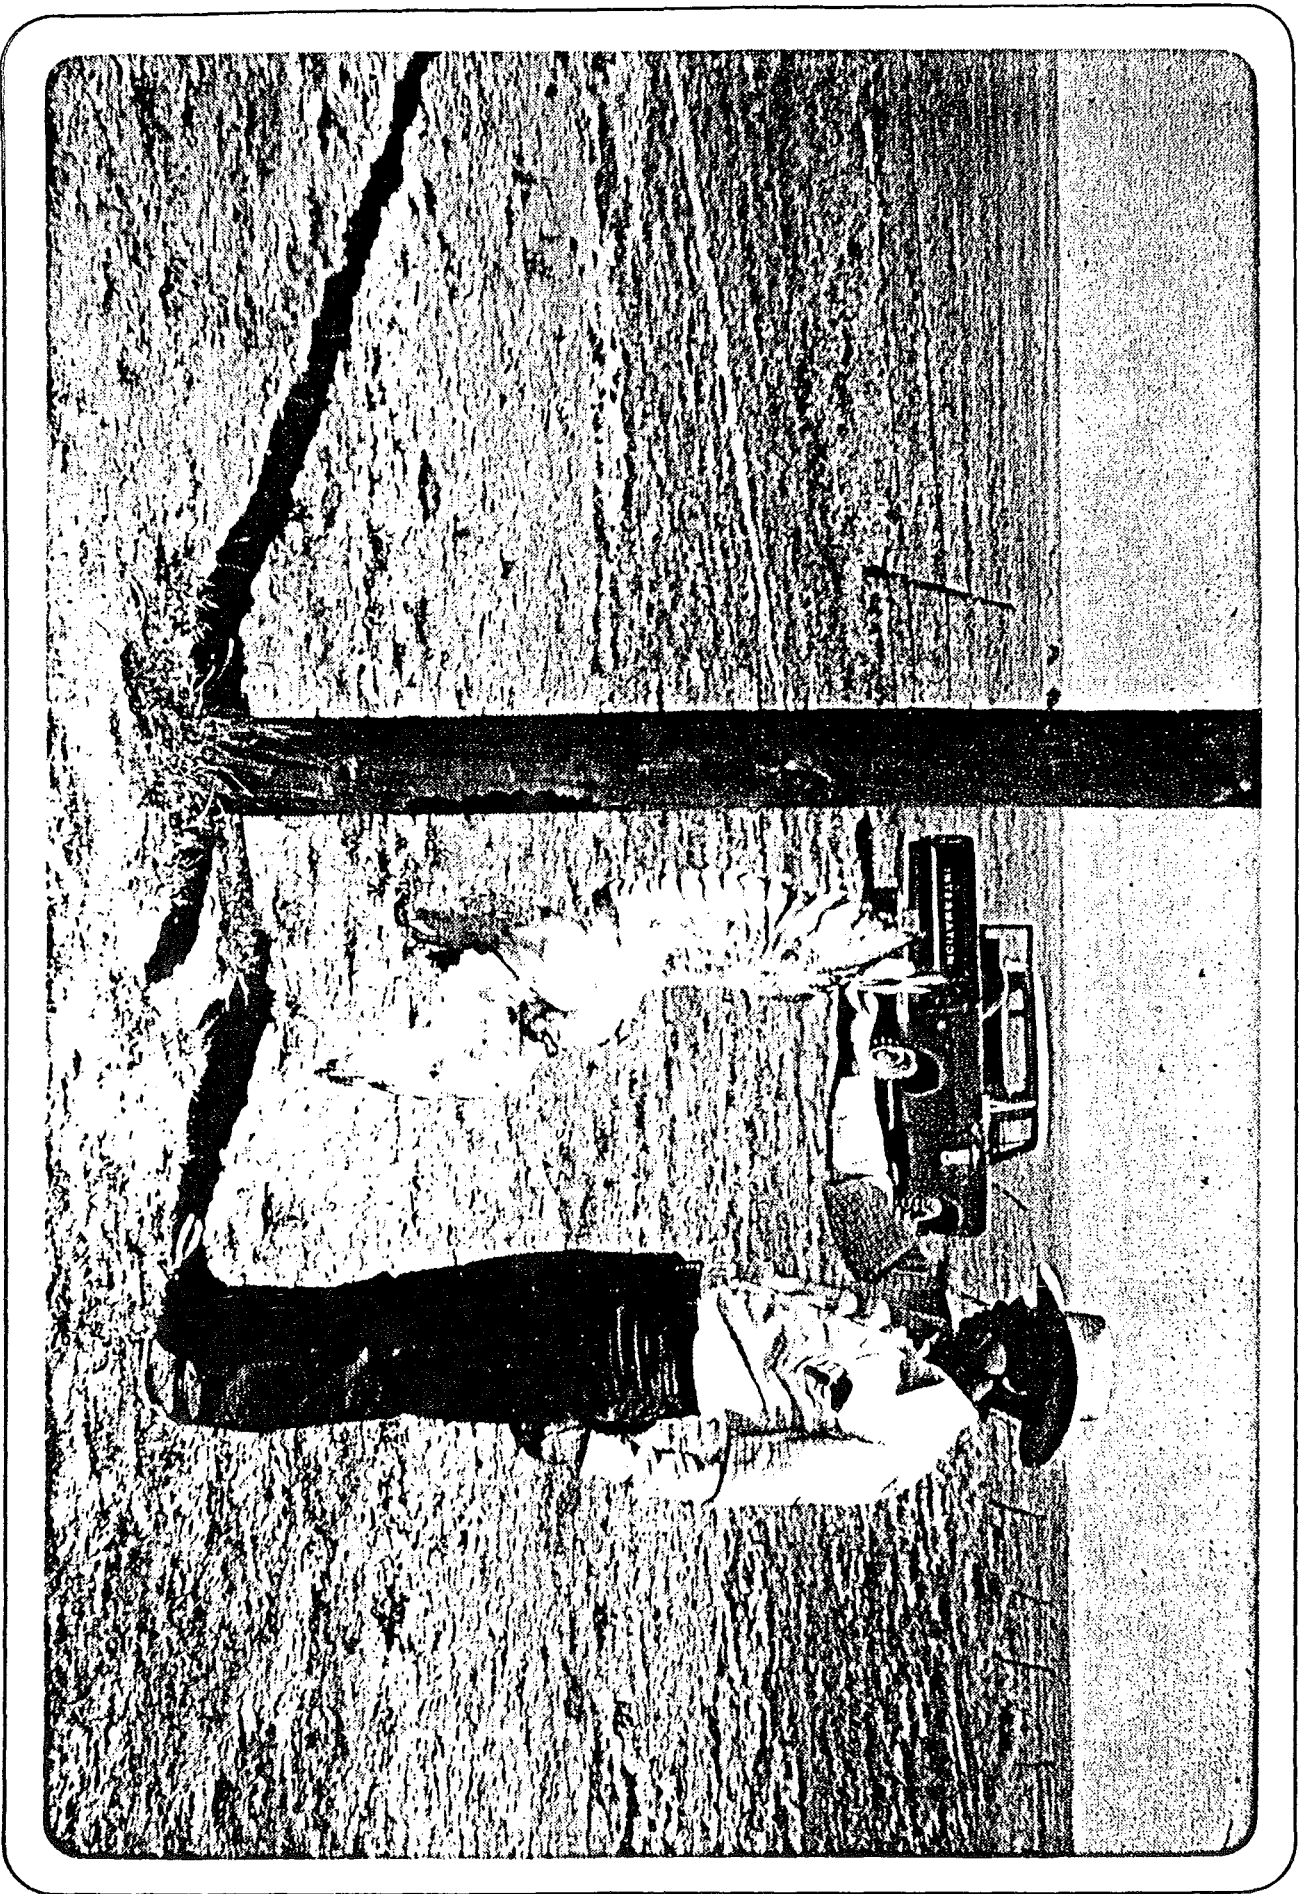
Several things can happen as a result of this entanglement: 1) the bird is electrocuted when it contacts the other wire while flapping its wings trying to escape; 2) the bird breaks its leg and either escapes or is allowed to come in contact with the other wire and is electrocuted; or 3) the entrapped bird eventually dies suspended upside down. Electrocution is a merciful death in the later situation.

The following describes the color photocopies of the 35 mm slides Mr. Keenan and I took of this power line hazard to raptors. Photocopies #2 and #3 show Mr. Keenan holding a dead Ferruginous Hawk that had become tangled on the power line, broke its leg, contacted the lower wire, and was electrocuted. The electrical charge going through its broken leg burned through the flesh at the break, and the bird dropped to the base of the power pole. The bird had been dead approximately one day when we discovered it. Photocopies #4 and #5 show the hawk's foot still entangled in the upper wire near the insulator. Note that a talon is entangled in the wire wrap that holds the power line to the insulator.

The entanglement hazard could have been avoided if the wire which holds the line to the insulator was more carefully wound during the construction of the power line. This would have eliminated the chances of a talon becoming entangled.

Existing entanglement problems could be corrected by: 1) tightly rewinding the wire that holds the power line to the insulator; or 2) installing a cover (split plastic tube) over the wire wrapping on each side of the insulator. Exhibit No. 3 in the report "Suggested Practices For Raptor Protection on Powerlines" distributed by the Raptor Research Foundation, Inc., for Edison Electric Institute, shows a method for covering the conductor and insulator.

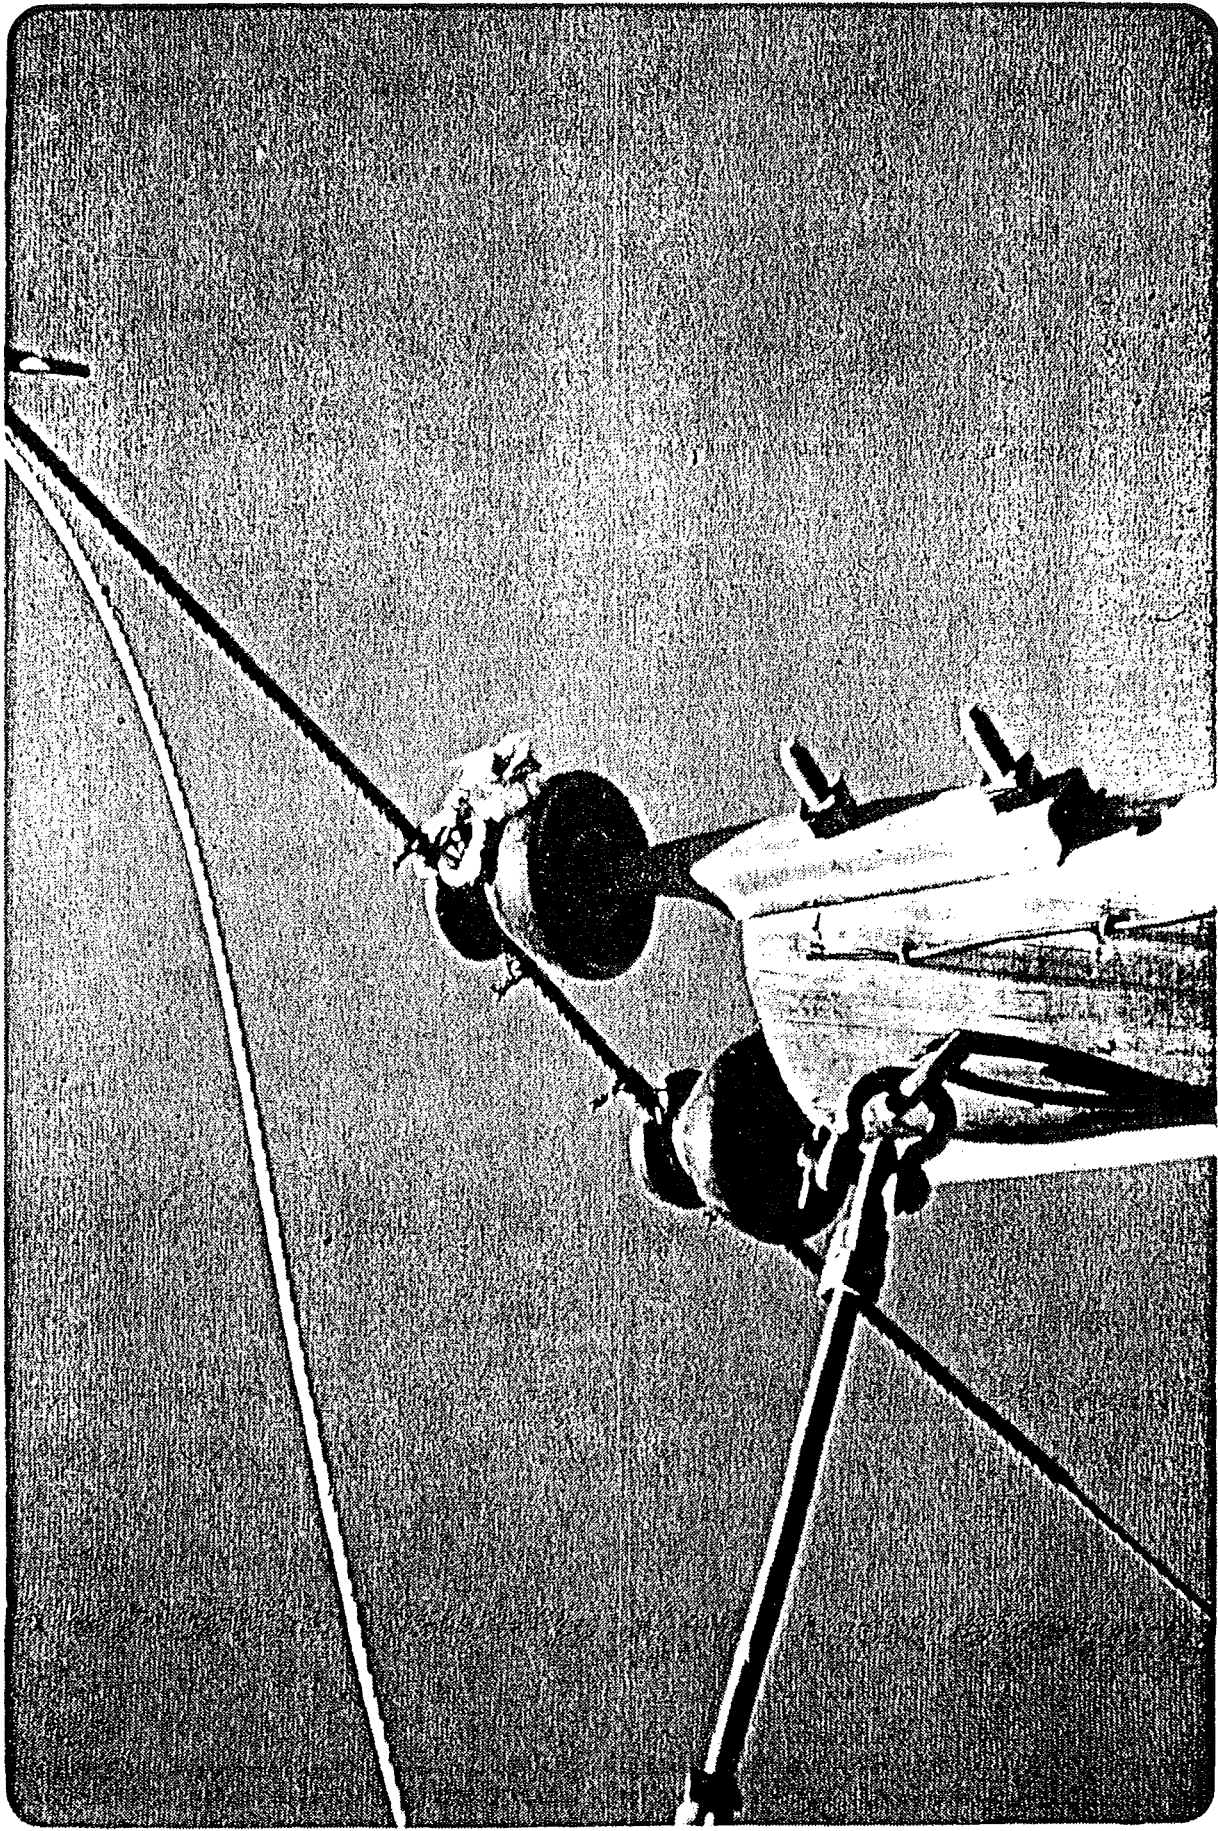
Photocopy #6 shows the foot of a golden eagle that became entangled in a similar manner on the same power line a week earlier--and was electrocuted. The eagle, discovered by Mr. Keenan at the base of the power pole, was first thought to have been victim of an electrocution problem.

The fact that the hawk and eagle were found on the same power line and that both were obviously electrocuted, emphasizes two important points: 1) a hazard identified for a particular power line is a good indicator that the rest of the line may need to be corrected; and 2) raptors killed by electrocution may cover up the initial problem of entanglement.
